RK HOME INSPECTIONS
(252) 703-1635
ryan@rkinspectionsnc.com
<https://www.rkinspectionsnc.com/>

RK DEFAULT TEMP

1234 Main Street
Rocky Mount, NC 27803

Buyer Name
01/17/2026 9:00AM

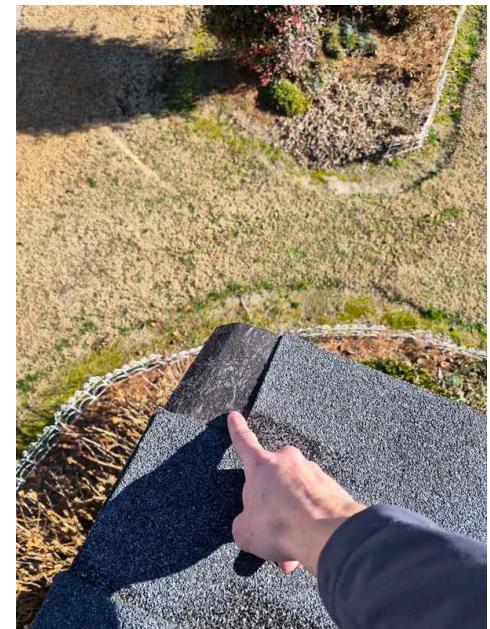
MISSING ROOF-COVERING MATERIAL

A section of the roof-covering material was missing. Missing material exposes underlying layers to water and can increase the risk of leaks and accelerated deterioration.

I recommend repair of the affected areas by a qualified roofing contractor.

Contact a qualified roofing professional.

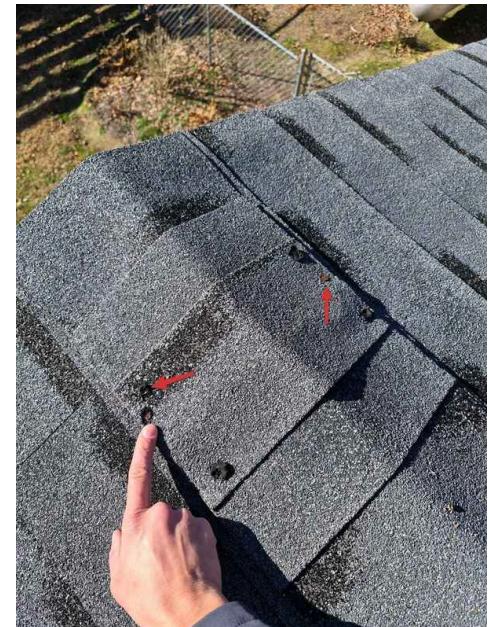
2.1.2 Roof Covering

EXPOSED FASTENERS

Fasteners were exposed on the roof surface. Exposed fasteners can loosen or corrode over time, providing a pathway for water to enter the roof system.

I recommend further evaluation and repair by a qualified roofing contractor.

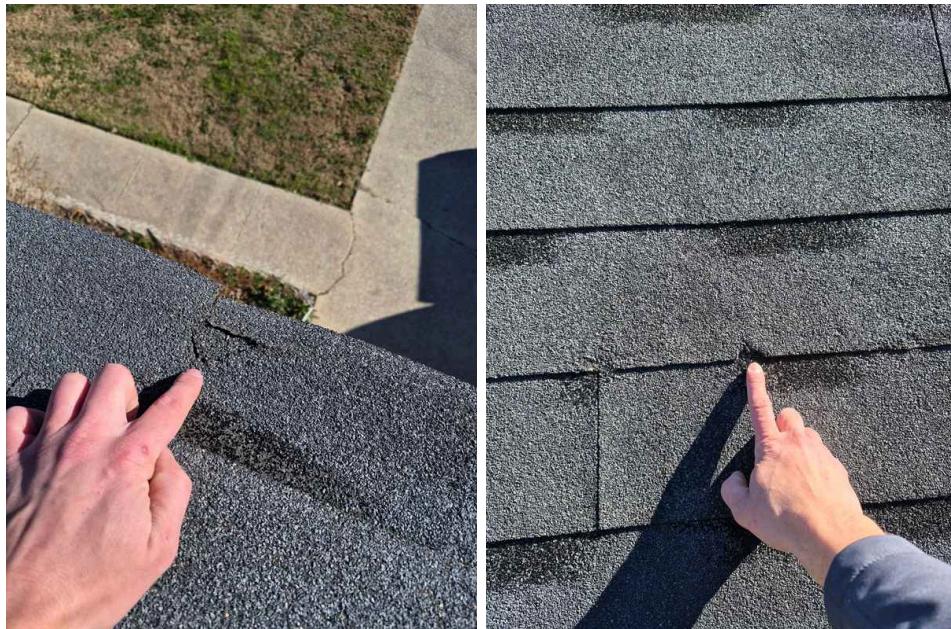
DAMAGED SHINGLES

Shingles were damaged or missing granules. Damaged shingles may not protect against water penetration and can accelerate deterioration of the roof system.

I recommend repair or replacement of the damaged shingles by a qualified roofing contractor.

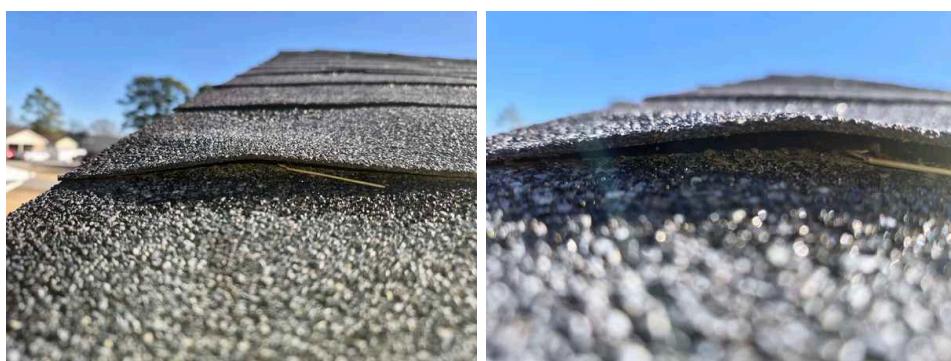
2.1.5 Roof Covering

IMPROPERLY FASTENED ROOF SHINGLE

One shingle was observed to be lifted due to a nail that was not properly secured. This can allow water intrusion and may lead to premature shingle wear or roof leaks if not corrected. Recommend proper fastening by a qualified roofing contractor.

Contact a qualified professional.

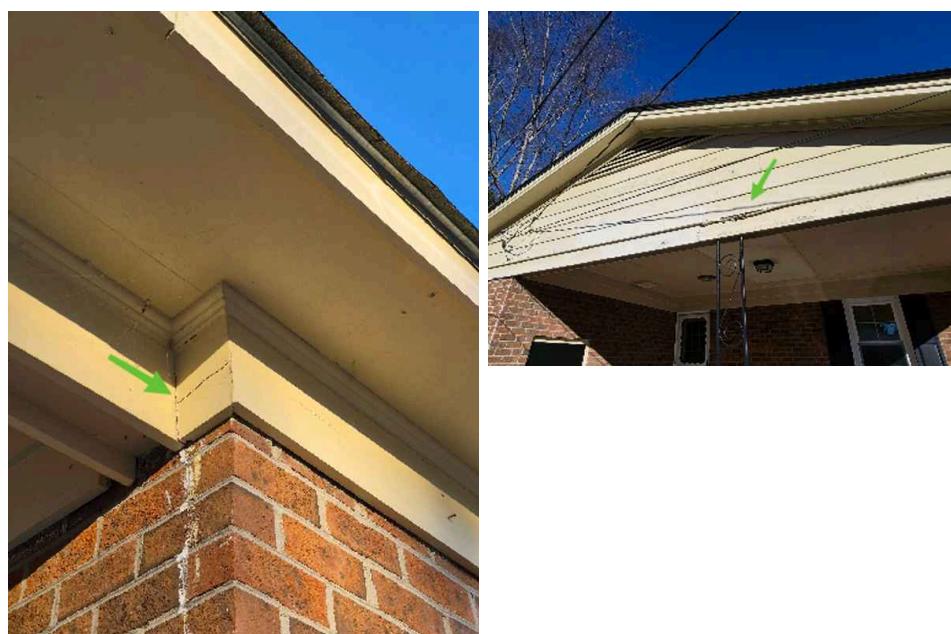
3.5.1 Flashing and Trim

DAMAGED EXTERIOR TRIM

Contact a qualified professional.

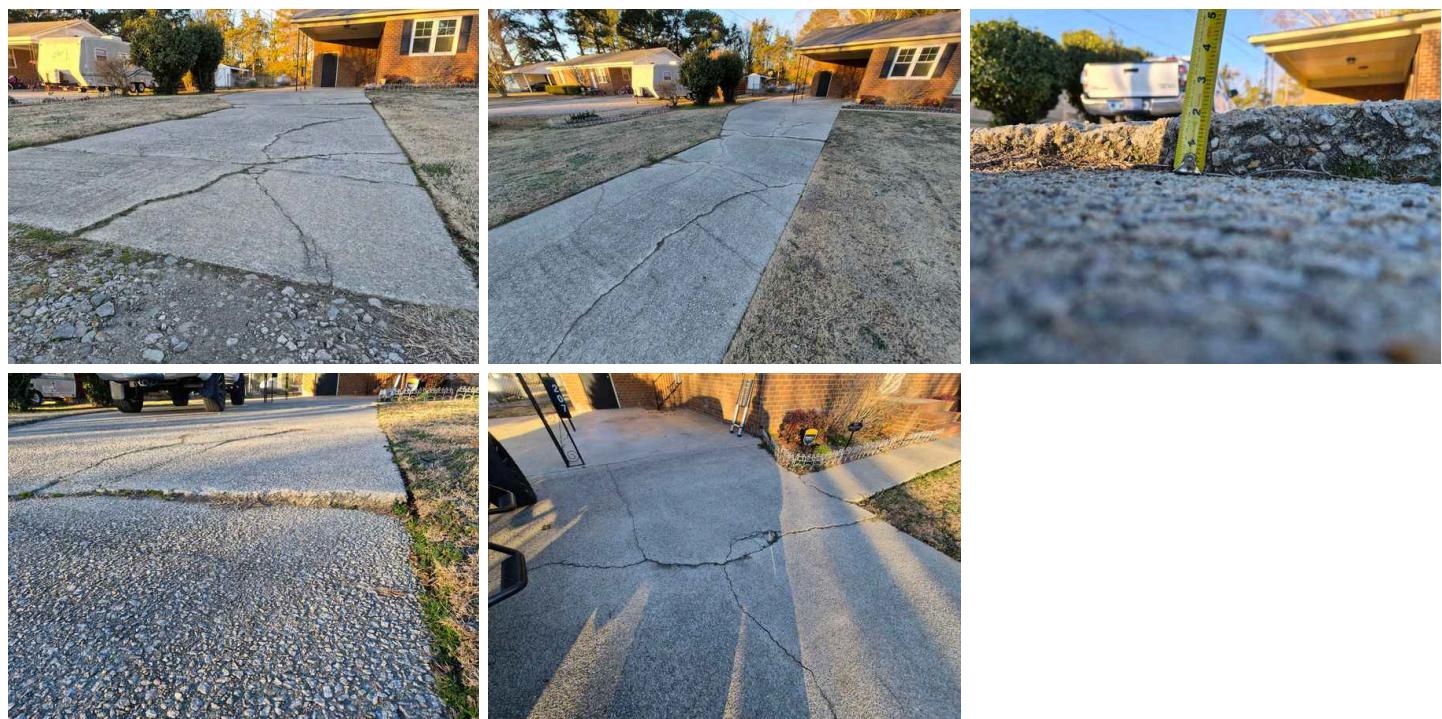
3.6.1 Adjacent Walkways and Driveways

MAJOR CRACKING AT DRIVEWAY

Contact a qualified concrete contractor.

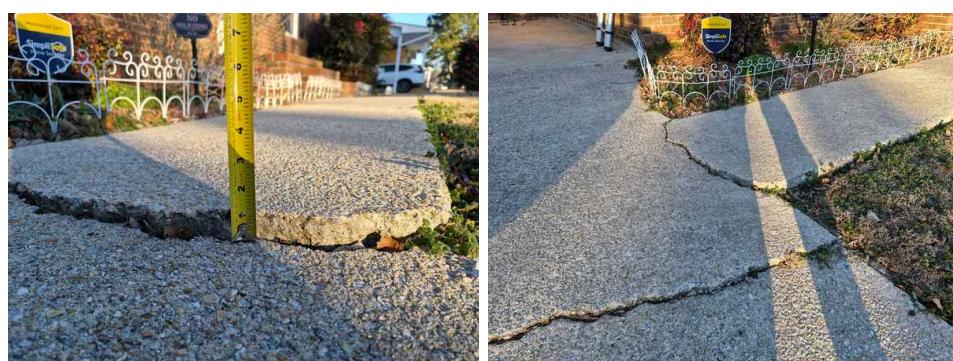
3.6.2 Adjacent Walkways and Driveways

SIGNIFICANT CRACKING OBSERVED AT WALKWAY

Contact a handyman or DIY project

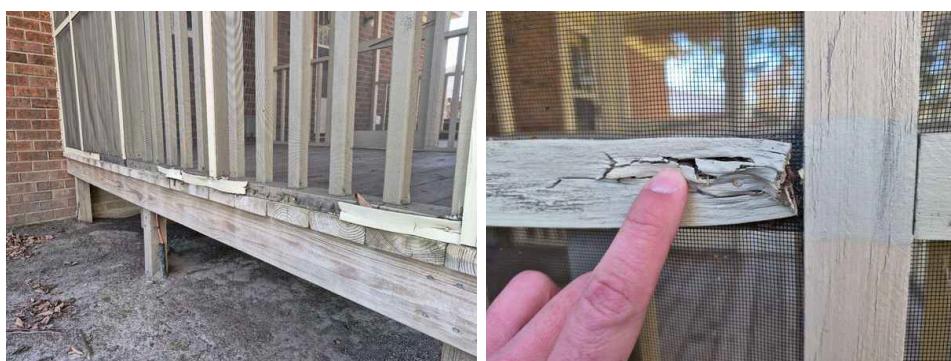
3.8.2 Porches, Patios, Decks, Balconies, and Carports

WATER-DAMAGED SCREEN COVERS OBSERVED

Contact a qualified professional.

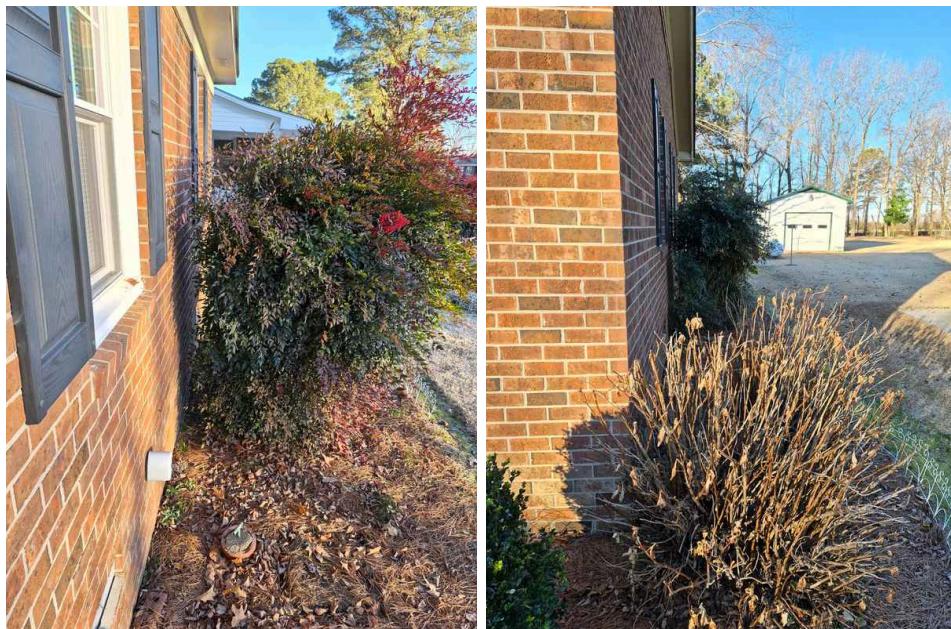
3.9.1 Vegetation, Surface Drainage, Retaining Walls, and Grading

VEGETATION CLOSE TO HOME

Contact a qualified professional.

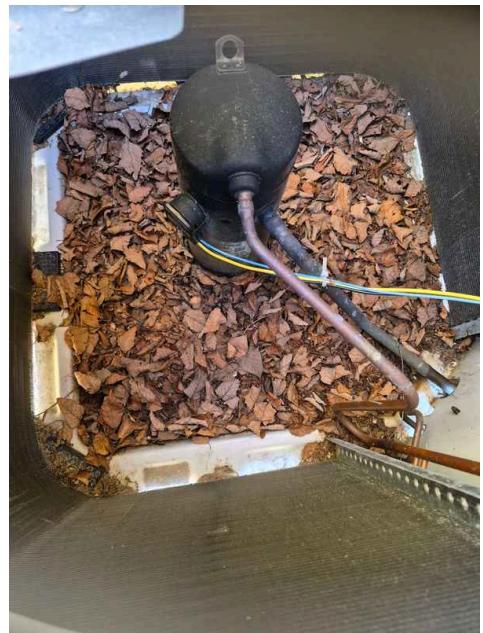
5.1.3 Cooling System Information

DEBRIS OBSERVED INSIDE A/C CONDENSER

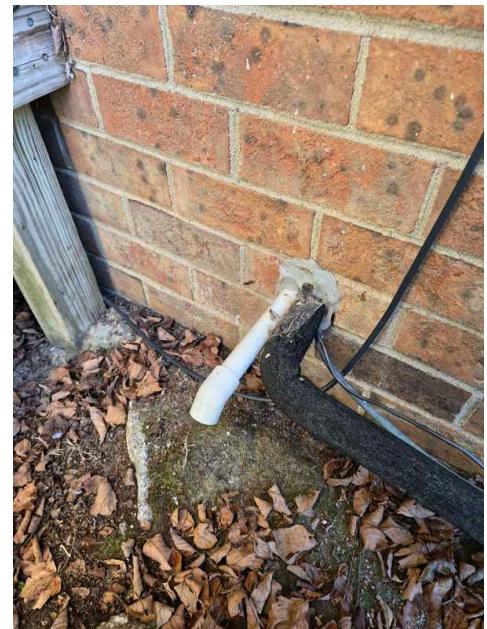
5.4.1 Condensate

CONDENSATE DISCHARGE SHOULD BE EXTENDED

Contact a qualified professional.

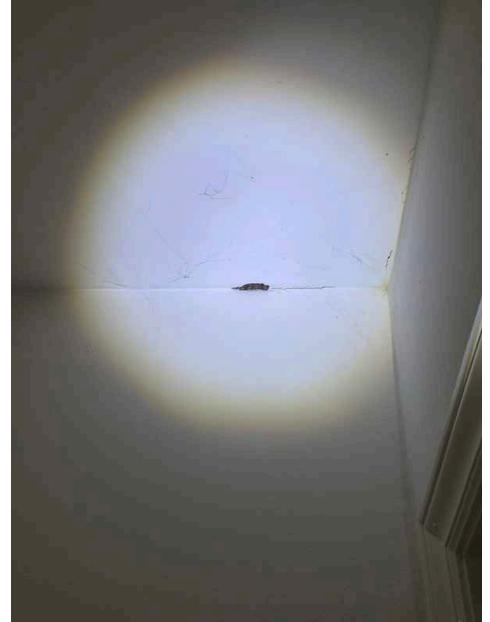
8.4.2 Floors, Walls, Ceilings

SMALL HOLE IN CLOSET CEILING

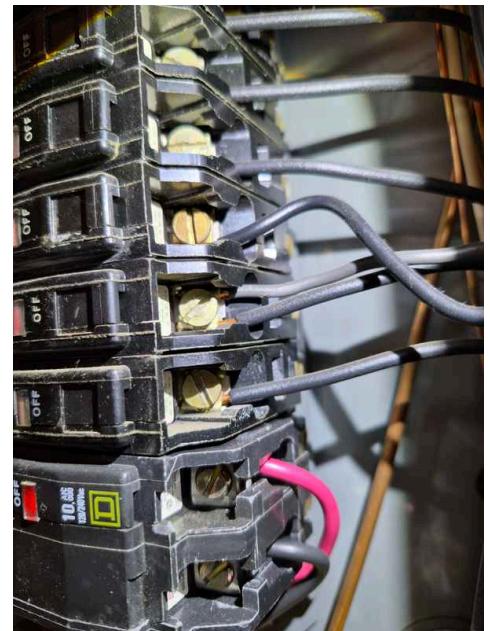
11.8.1 Panelboards & Breakers

TWO CONDUCTORS ON SINGLE BREAKER

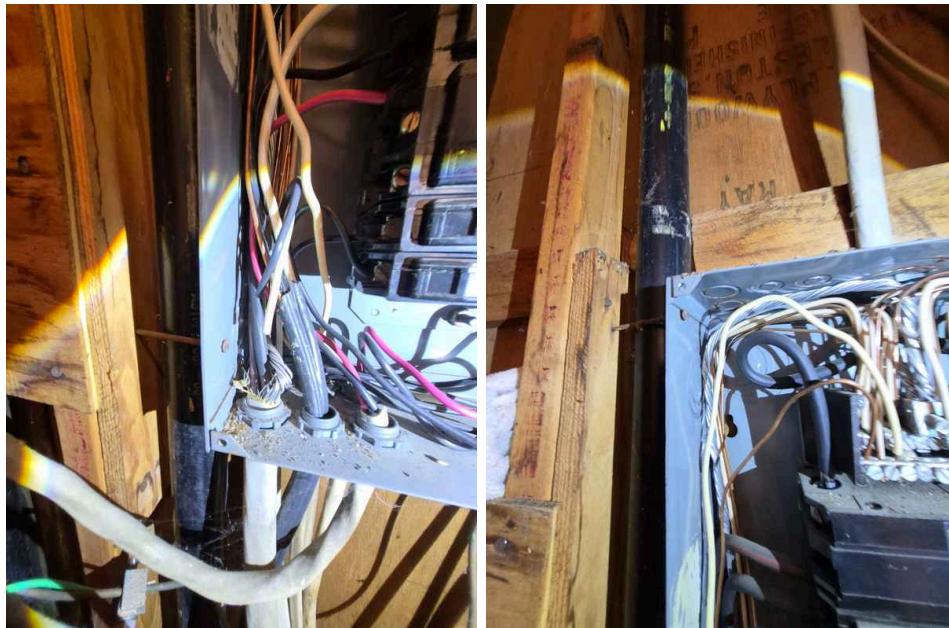
11.8.2 Panelboards & Breakers

IMPROPER PANEL MOUNTING

Contact a qualified professional.

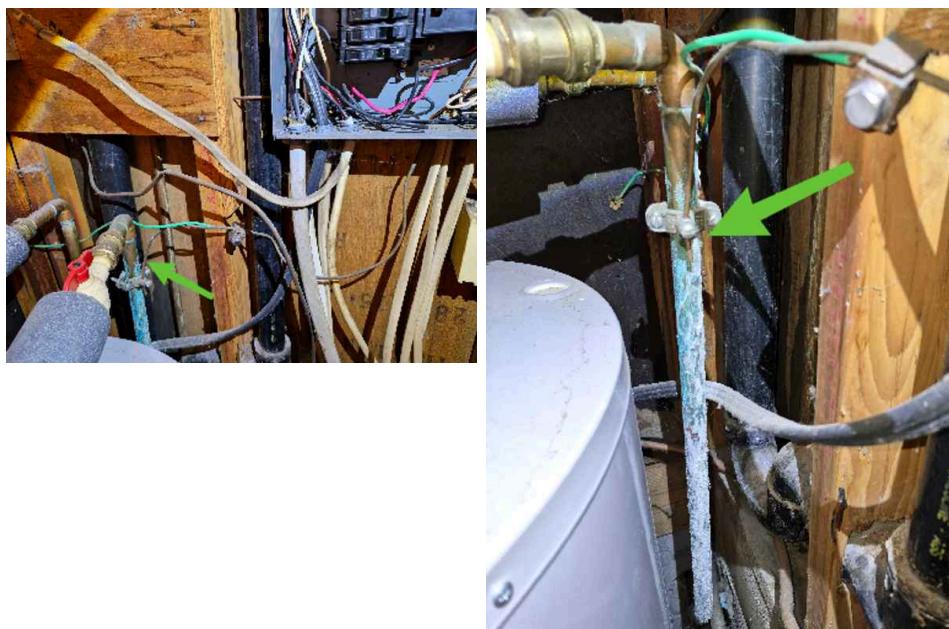
11.9.1 Service Grounding & Bonding

MAIN PANEL BONDED TO CORRODED WATER PIPE

Contact a qualified professional.

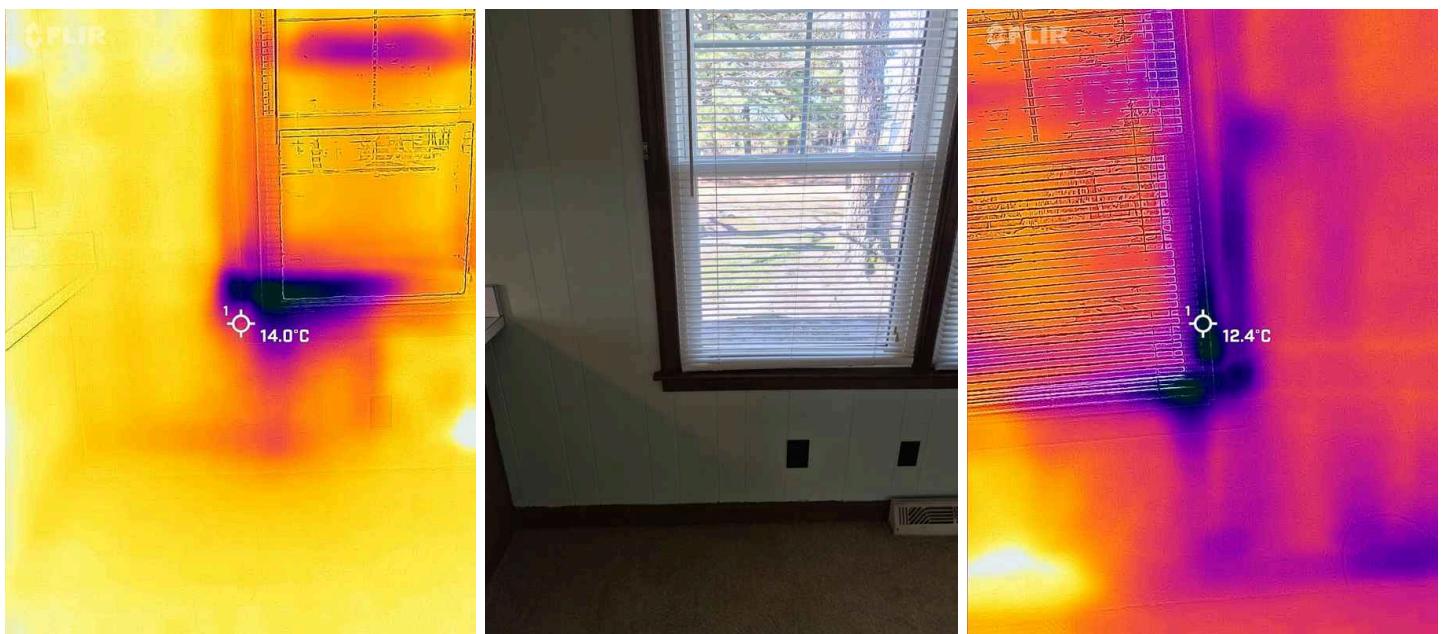
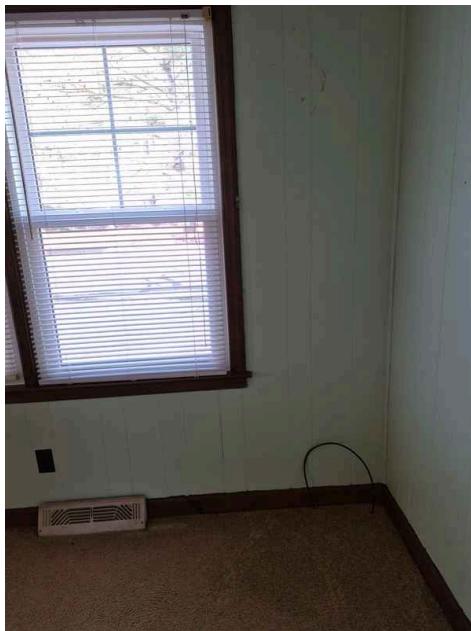
12.3.1 Living Room Window

COLD SPOTS OBSERVED AT LIVING ROOM WINDOW

Contact a qualified professional.

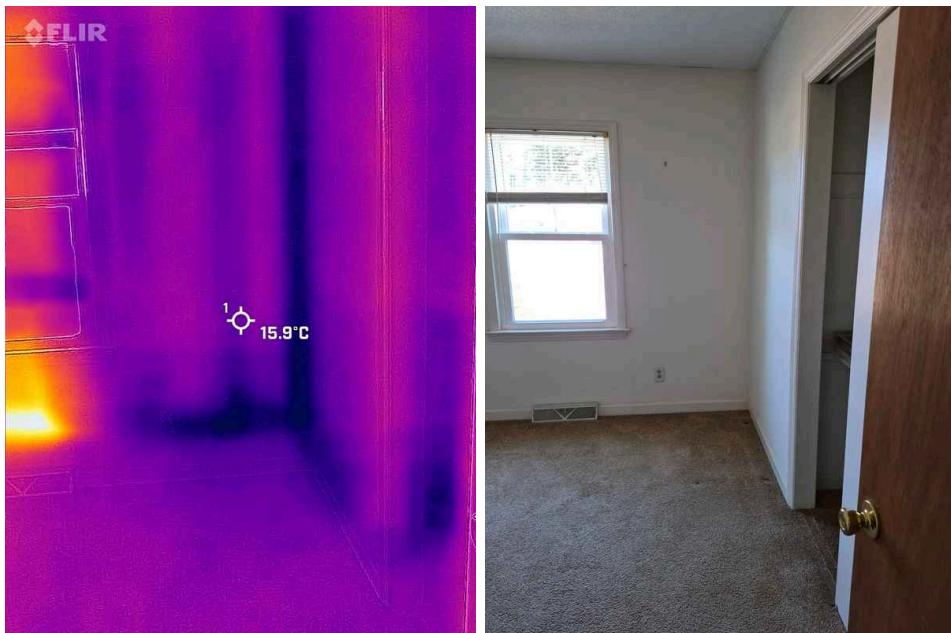
12.4.1 First Bedroom

COLD SPOTS OBSERVED AT BEDROOM CORNER WALL

Contact a qualified professional.

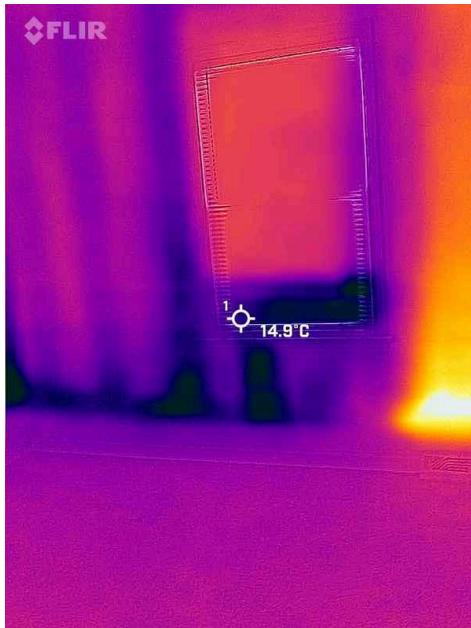
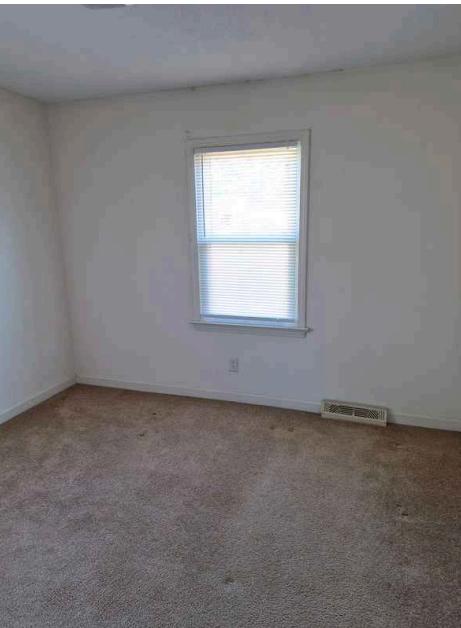
12.5.1 Back Right Room

COLD SPOTS OBSERVED UNDER WINDOW – BACK RIGHT ROOM (WINDOW 1)

Contact a qualified professional.

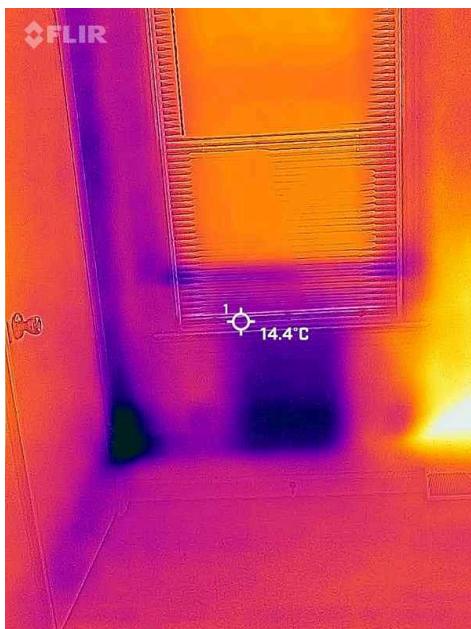
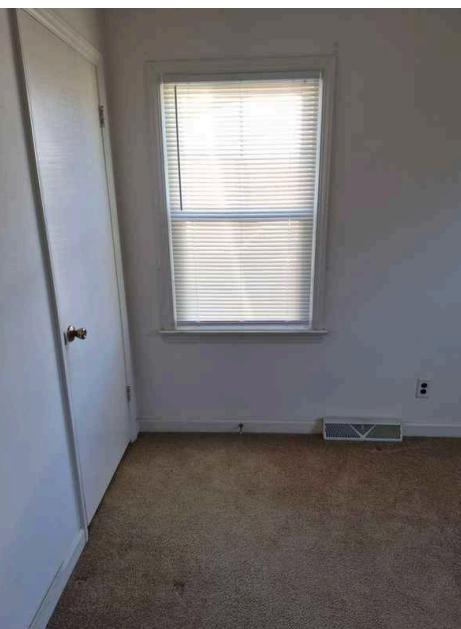
12.5.2 Back Right Room

LARGE COLD SPOT OBSERVED UNDER WINDOW – BACK RIGHT ROOM (WINDOW 2)

Contact a qualified professional.

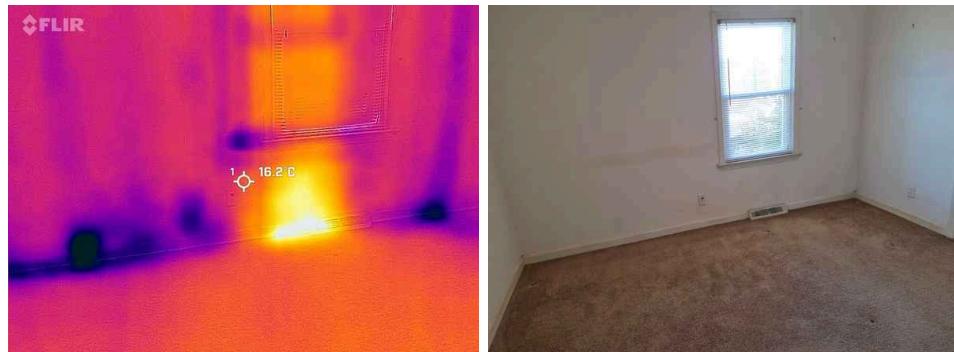
12.6.1 Master Bedroom

COLD SPOTS OBSERVED AT MASTER BEDROOM WALL CORNERS

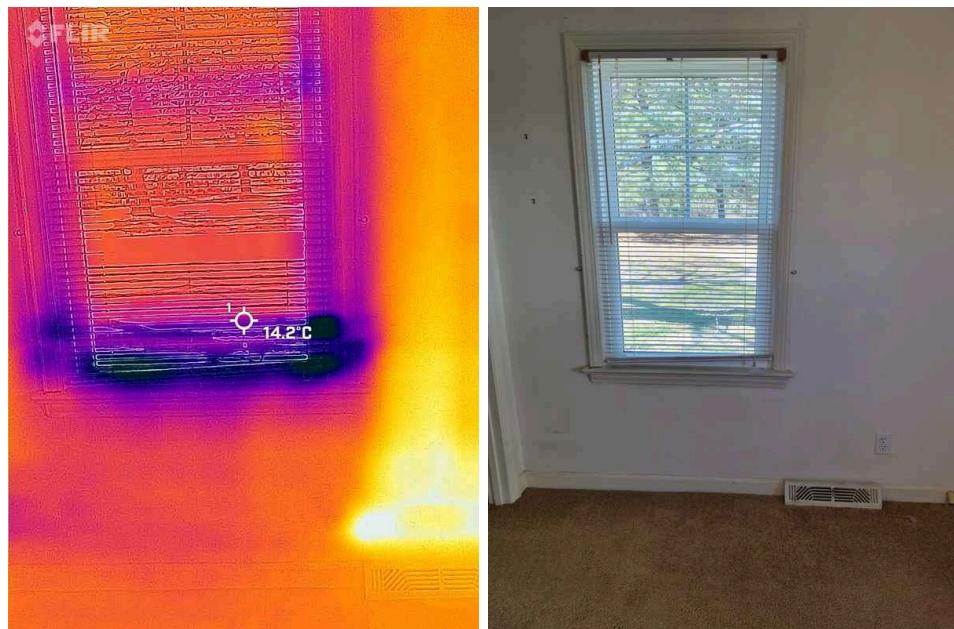
12.6.2 Master Bedroom

COLD SPOTS OBSERVED AT MASTER BEDROOM WINDOW SILL

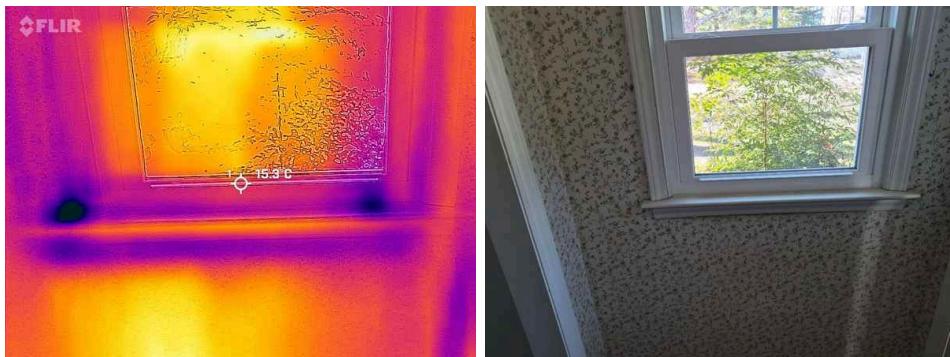
12.7.1 Master Bathroom

COLD SPOTS OBSERVED AT MASTER BATHROOM WINDOW

Contact a qualified professional.
