RK HOME INSPECTIONS
(252) 703-1635
ryan@rkinspectionsnc.com
<https://www.rkinspectionsnc.com/>

RK DEFAULT TEMP

1234 Main Street
Rocky Mount, NC 27803

Buyer Name
01/17/2026 9:00AM

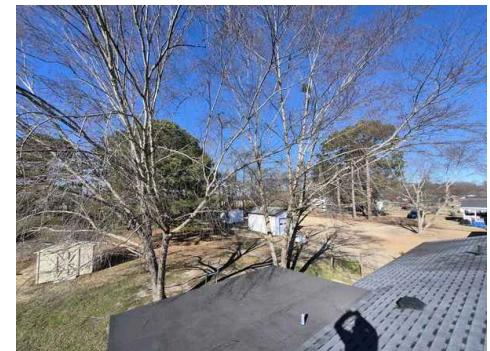
2.1.4 Roof Covering

DAMAGED SHINGLES

Shingles were damaged or missing granules. Damaged shingles may not protect against water penetration and can accelerate deterioration of the roof system.

I recommend repair or replacement of the damaged shingles by a qualified roofing contractor.

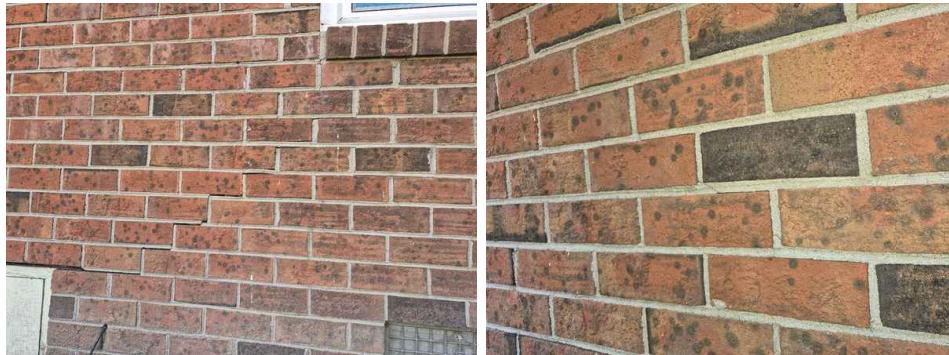
3.1.2 Exterior Wall-Covering Materials

STEP CRACKING AT RIGHT-SIDE BRICK VENEER NEAR WINDOW

Contact a qualified masonry professional.

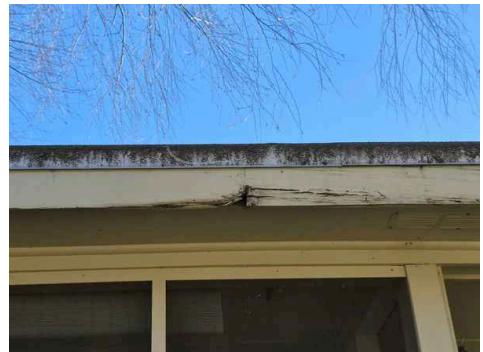
3.2.2 Eaves, Soffits, and Fascia

PAINT SURFACE IN POOR CONDITION

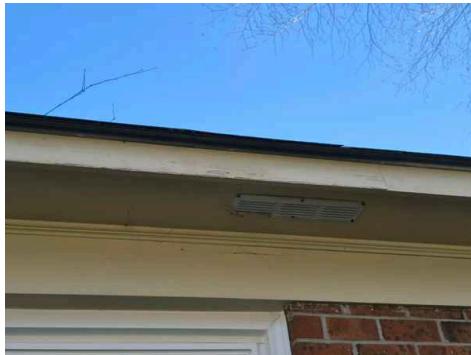
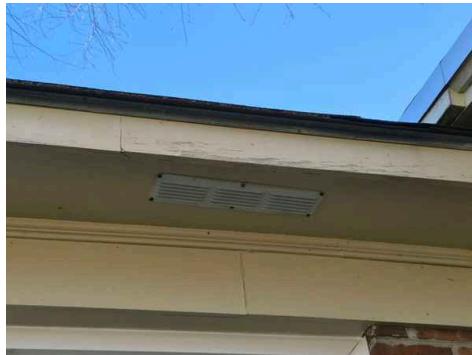
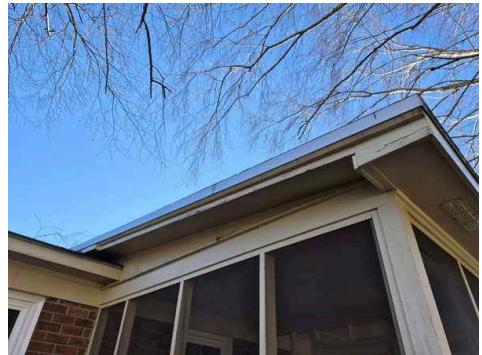
3.2.3 Eaves, Soffits, and Fascia

FASCIA BOARD JOINT MISSING / WORN CAULKING

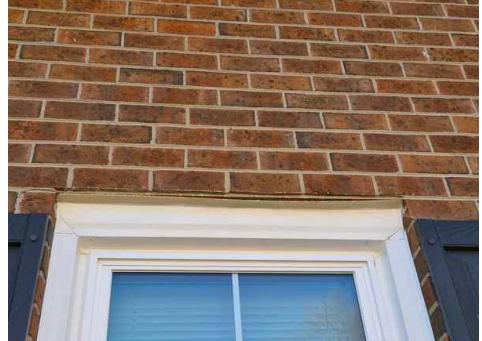
3.3.1 Representative Number of Windows

**BOWING WINDOW LINTEL OBSERVED ON
LEFT SIDE OF HOME**

The lintel above the window on the left side of the home was observed to be bowing and showing signs of damage. A damaged or deflected lintel may indicate inadequate support and can contribute to cracking or movement in the surrounding masonry. I recommend further evaluation and repair by a qualified masonry contractor or structural engineer to correct the condition and prevent further deterioration.

Contact a qualified professional.

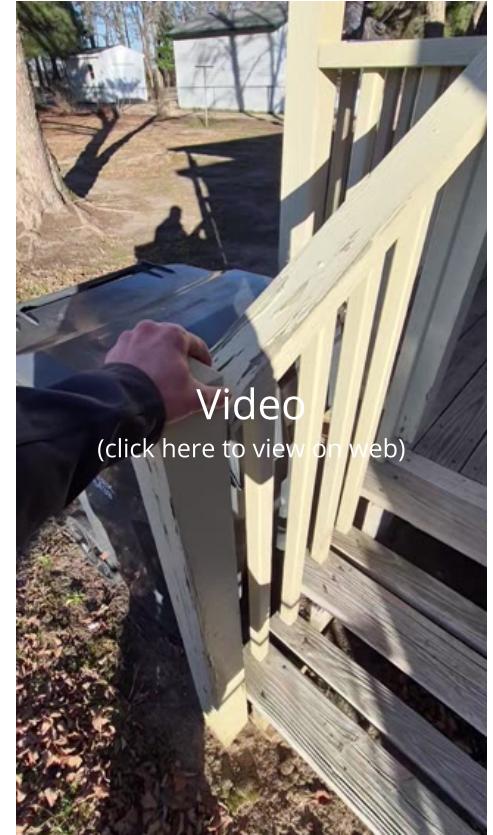
LOOSE HANDRAIL ON REAR DECK STAIRS

The handrail on the rear deck stairs is loose and not properly attached at the bottom post, creating a safety hazard. I recommend a qualified deck contractor secure the handrail to ensure stability and safe use.

Contact a qualified deck contractor.

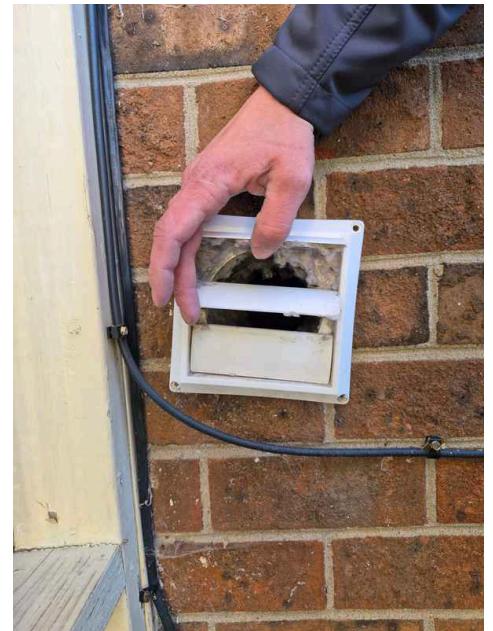
3.11.1 Exhaust Hoods

CLOGGED DRYER EXHAUST HOOD

The exhaust hood connected to the clothes dryer was observed to be clogged. Accumulated lint can ignite from the dryer's heat, creating a fire hazard. I recommend further evaluation and cleaning by a qualified dryer vent cleaning professional to ensure safe operation.

Contact a qualified appliance repair professional.

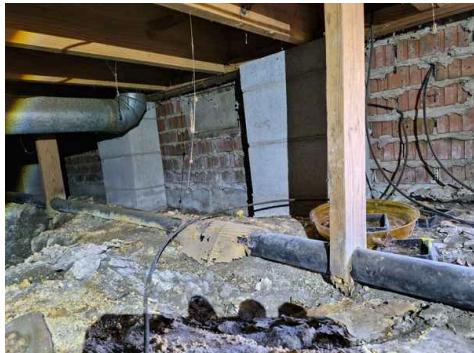
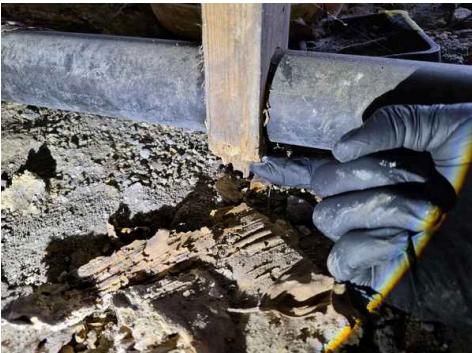
4.2.1 Under-Floor Crawlspace

Wooden structural components were observed in contact with or close to soil, which can allow water penetration and lead to deterioration or structural damage. I recommend further evaluation and corrective measures by a qualified general contractor or structural professional to prevent water-related damage.

Contact a qualified general contractor.

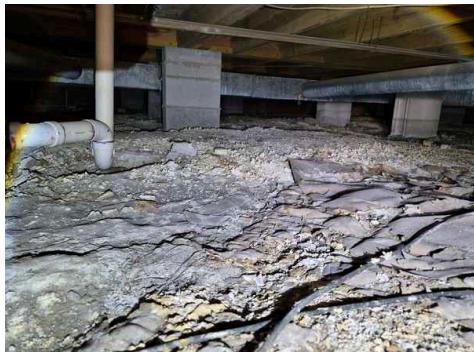
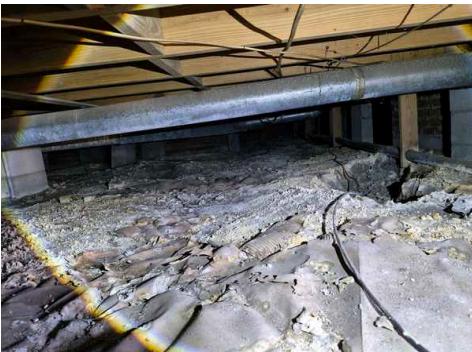
4.2.2 Under-Floor Crawlspace

MISSING CRAWL SPACE VAPOR BARRIER

A vapor retarder was not present on the crawl space floor. Missing vapor barriers can allow ground moisture to enter the crawl space, increasing the risk of elevated humidity, wood deterioration, and mold growth. Recommend installation of a proper vapor barrier.

Contact a qualified professional.

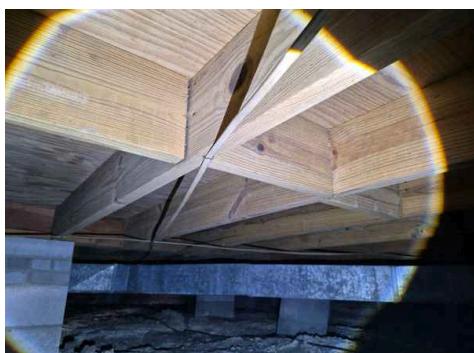
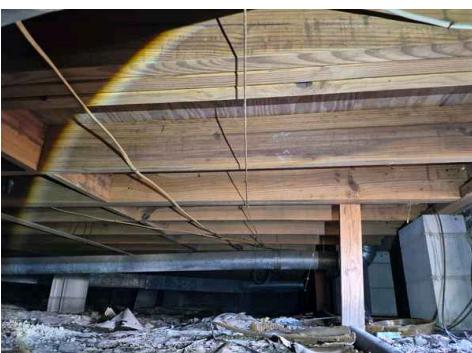
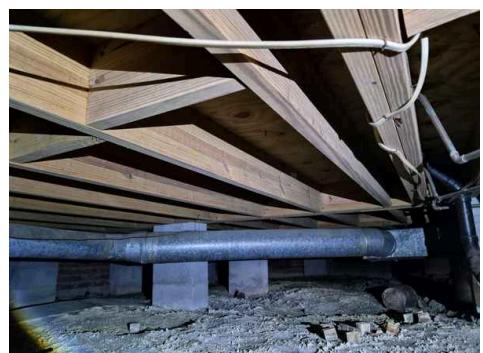
4.2.3 Under-Floor Crawlspace

NO INSULATION PRESENT IN CRAWLSPACE

No insulation was present in the crawlspace at the time of inspection. Lack of insulation can result in heat loss, higher energy costs, cold floors above, and increased risk of moisture and condensation issues. Recommend installation of proper insulation by a qualified contractor to improve energy efficiency and overall comfort.

Contact a qualified professional.

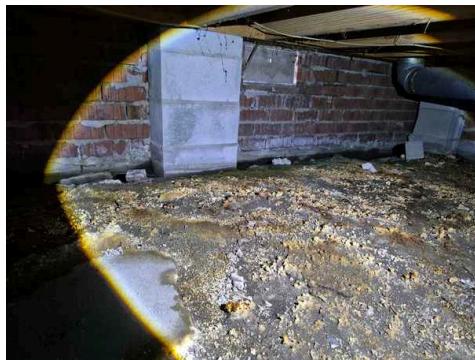
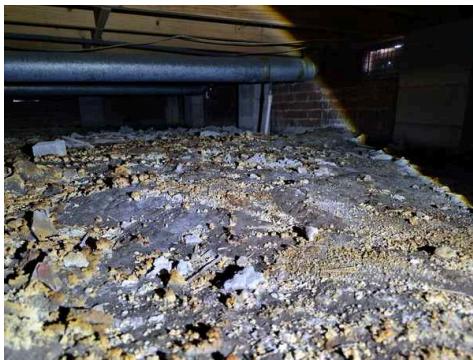
4.2.4 Under-Floor Crawlspace

Organic growth-like material was observed on the soil surface in the crawlspace. The area was noted to have elevated moisture conditions at the time of inspection. Excess moisture can promote microbial growth and may lead to wood deterioration and air quality concerns. Recommend further evaluation and correction of moisture conditions by a qualified professional, and additional assessment of the material as needed.

Contact a qualified professional.

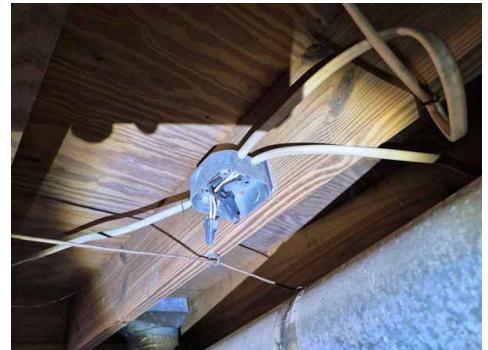
4.2.5 Under-Floor Crawlspace

**OPEN ELECTRICAL SPLICES OBSERVED IN CRAWLSPACE**

Open splices were observed in the crawlspace wiring. Exposed connections can pose a risk of electrical shock or fire if not properly enclosed. Recommend evaluation and correction by a licensed electrician.

Contact a qualified professional.

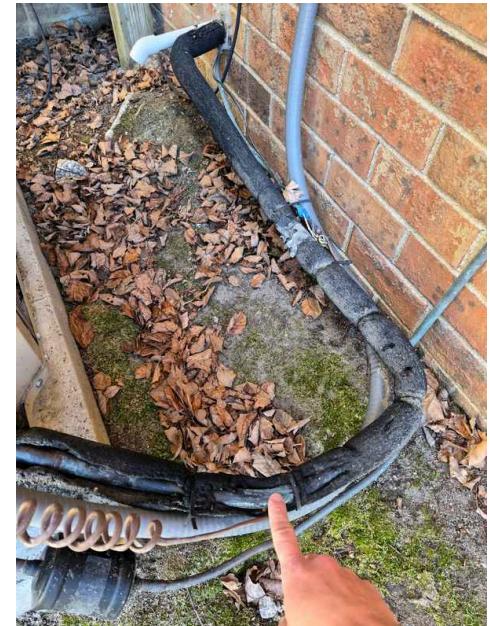
The cooling system was not operated because outside temperatures were too low, which could damage the system. This is an inspection limitation. I recommend asking the homeowner about the system's condition, including past performance, and having it evaluated by a qualified HVAC contractor when conditions allow safe operation.

Contact a qualified HVAC professional.

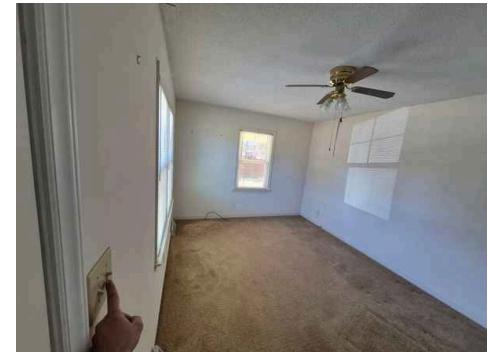
8.4.1 Floors, Walls, Ceilings

CEILING PAINT CRACKING AT CORNERS

Cracking or chipping was observed at the drywall tape in the ceiling corners, which may be caused by normal settling or minor movement. I recommend repair by a qualified painter or drywall contractor to restore a finished appearance and prevent further deterioration.

Contact a qualified painting contractor.

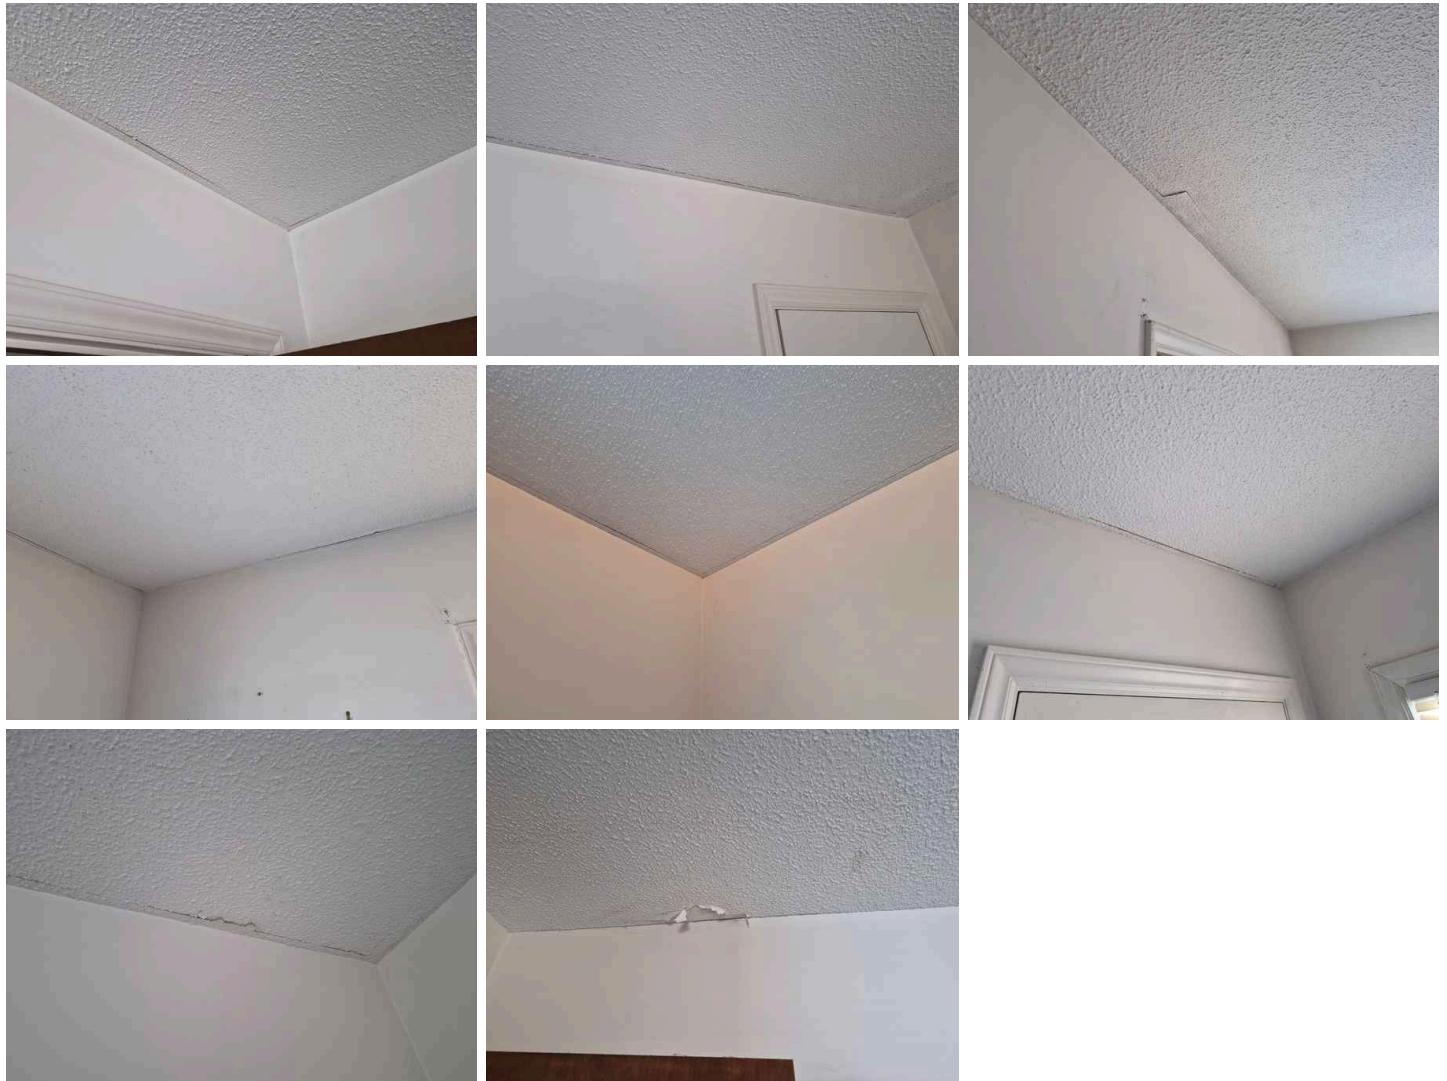
8.4.2 Floors, Walls, Ceilings

SMALL HOLE IN CLOSET CEILING

A small hole was observed in the ceiling of the first-room closet, which can allow interior air to escape into the attic, potentially affecting energy efficiency and moisture control. I recommend repair by a qualified painter or drywall contractor to seal the opening and restore proper separation between living space and attic.

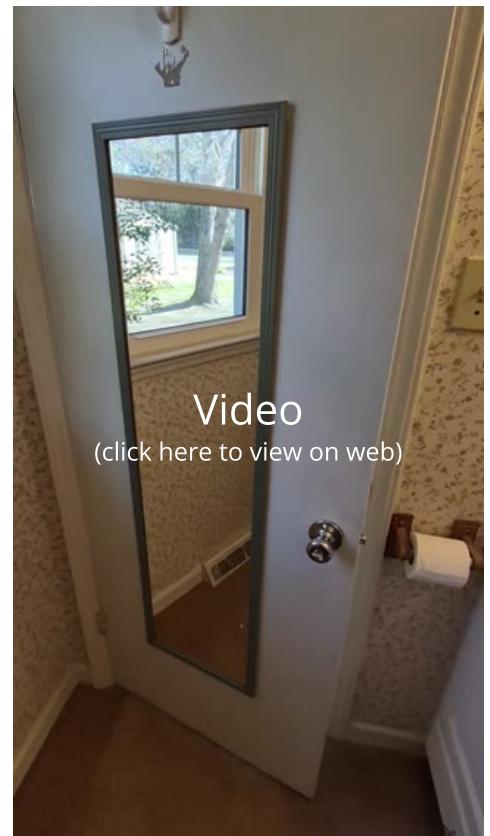
9.6.1 Door

LOOSE DOOR HINGE

The bathroom door hinge is loose, causing the door to slowly swing open on its own. I recommend tightening or replacing the hinge by a qualified carpenter or handyman to ensure proper door function and safety.

Contact a qualified professional.

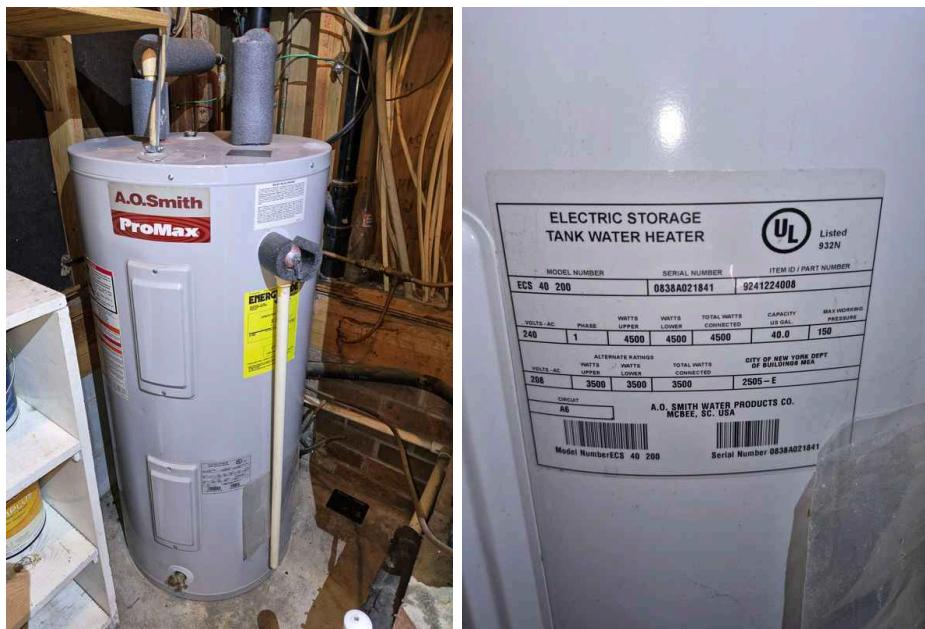
The hot water source was visually inspected and tested where possible. I checked for general condition, operation, and signs of leaks or deterioration.

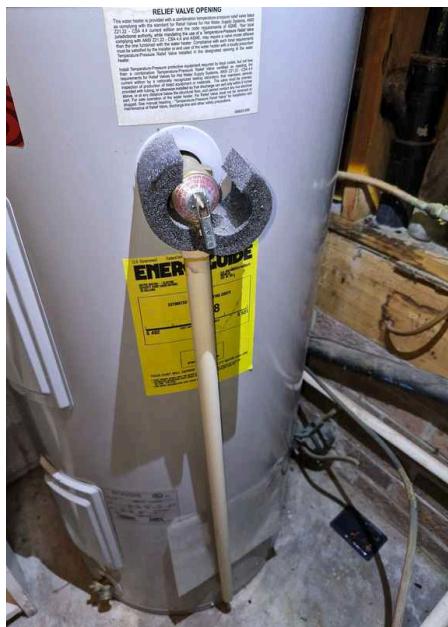
The Temperature and Pressure Relief (TPR) valve was observed and inspected for proper presence and installation. This valve is a critical safety device on the water heater.

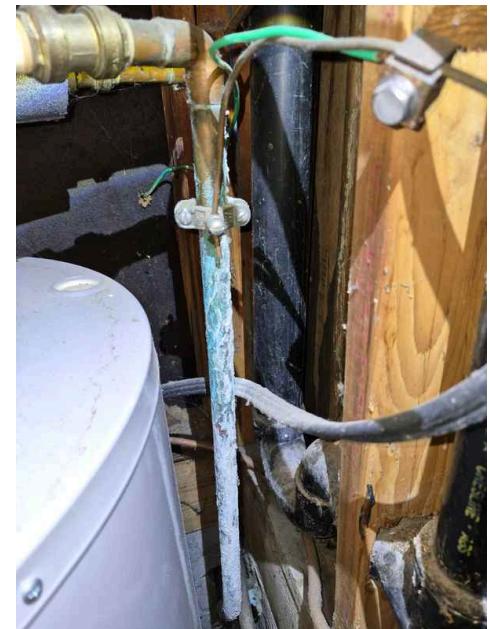
CORROSION CORRODED COPPER PIPE AT WATER HEATER

Heavy corrosion and buildup were observed on the copper cold water supply line near the water heater. Corrosion can weaken the pipe over time and lead to leaks or water damage. Recommend evaluation and repair by a licensed plumber, including cleaning or replacement of the affected pipe and correction of the underlying cause.

Major Defect

Contact a qualified plumbing contractor.

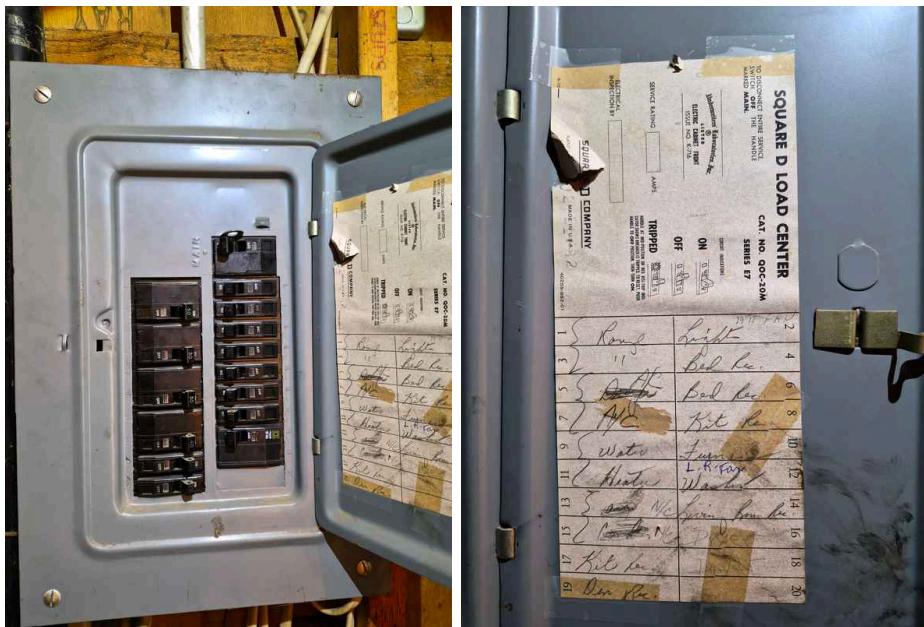
The main electrical panelboard and breakers were visually inspected. I checked for general condition, proper labeling, and any visible signs of damage or wear.

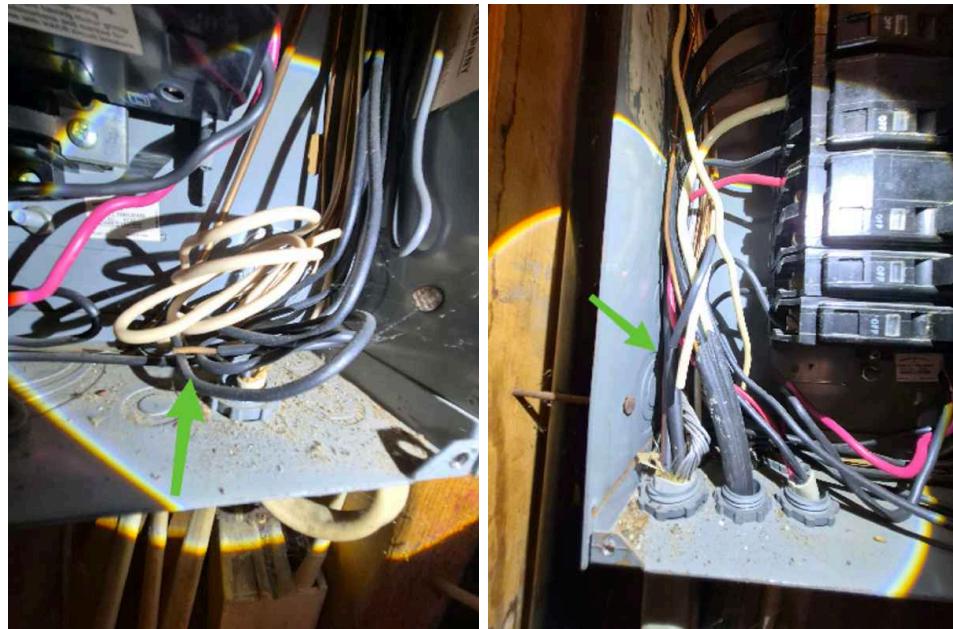
Material Defect

Three wires in the panel were not capped or terminated with wire nuts, leaving exposed conductors. Two of these wires were positioned near a framing nail securing the panel, increasing the risk of accidental contact or short circuit. This creates a potential shock and fire hazard. Recommend a licensed electrician properly cap or terminate the wires and ensure safe clearance from the panel mounting hardware.

Contact a qualified professional.

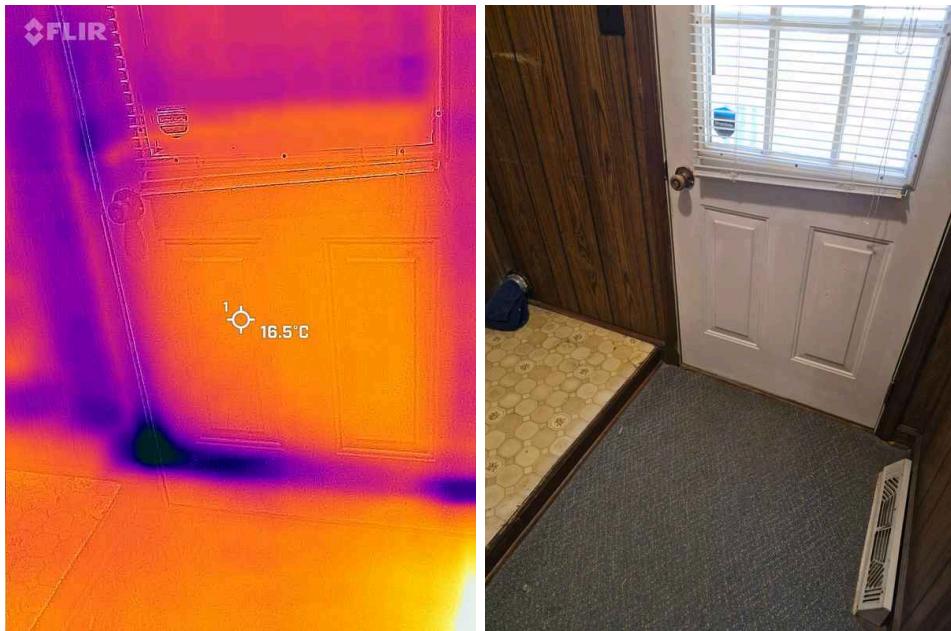
COLD SPOT OBSERVED AT BACK DOOR

Cold spot observed at the bottom left corner of the door, indicating possible air infiltration. This may contribute to drafts and higher energy costs. Recommend sealing or weatherstripping by a qualified contractor.

Major Defect
